Navajo Abandoned Uranium Mine

Site Screen Report

NA-0420 AUM Site

August 2010

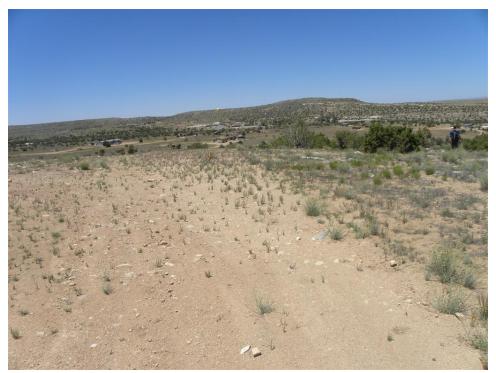
Photo 1. NA-0420 site

There is the possibility that the site has been reclaimed with a soil and/or gravel cap; concrete pad was located immediately S of site.

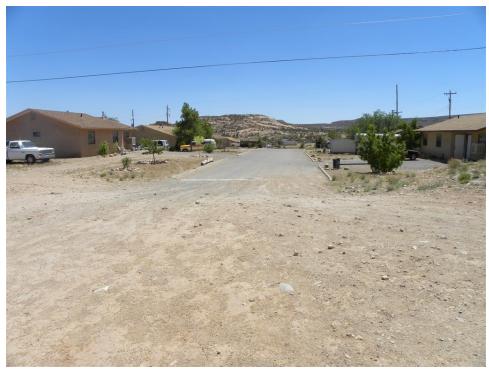
200 feet to 0.25 mile: Large neighborhood of homes directly S of site, approx 300 feet

Transect of houses revealed no radiological readings above background levels

Photo 3. NA-0420 site, houses directly S of site

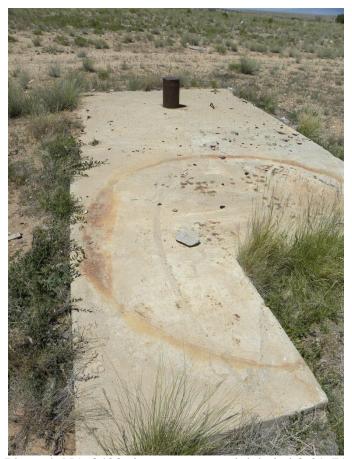
Photo 4. NA-0420 site, concrete pad, labeled 3-29-71
